**PETTY REBUTTAL REPORT**

**Plaintiff(s): CeramFab, Inc., CeramSource, Inc, Yonggong, LLC, WYG  
Refractories, LLC and CeramSource, Inc.**

**Defendant(s): Norfolk Southern Corporation and Norfolk Southern  
Railway Company (Defendants).**

**Mr. Stephen E. Petty, P.E., C.I.H., C.S.P.  
Engineering & Expert Services, Inc.  
(EES Group, Inc.)**

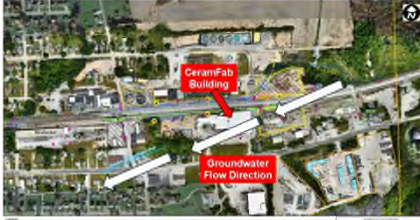
| Locations of Text | Text or Summary of Statements | Rebuttal Comments on Text or Statements |
|---|---|---|
| Pg. 6.<br>Figure 2 and<br>Section 3.1.2<br>Surface<br>Water | <p><b>Figure 2 depicts the general shallow aquifer groundwater flow direction.</b></p> <p><b>Figure 2. Regional Inferred Groundwater Flow in East Palestine, Ohio</b></p> <p><b>3.1.2 Surface Water</b></p> <p>Surface water from Columbiana County is within the Little Beaver Creek Watershed of the Ohio River drainage basin. East Palestine is drained by tributaries Sulphur Run and Leslie Run, which generally flow to the south through East Palestine.<sup>12</sup> Wetlands and State Line Lake are located immediately northeast of the Derailment Site.<sup>13</sup></p> <p>Surface water drainage along the train tracks flows toward two ditches (north and south) aligned parallel to the Mainline tracks and flowing west for approximately 1,000 feet before discharging into Sulphur Run. Sulphur Run joins Leslie Run about one-half mile to the west-southwest, then flows into Bull Creek, and continues to the North Fork of Little Beaver Creek and Little Beaver Creek before discharging to the Ohio River.<sup>14</sup></p> | <p>Dr. Love's description of shallow groundwater flow reflects general references but appears to ignore actual flow information from monitoring well data (Petty Report – Exhibit 180, pgs. 48-49 &amp; Figure 7.6 – Exh. 55) where Arcadis shows flow to the west/southwest:</p> <p>Engineering &amp; Expert Services, Inc.® 49 April 6, 2026</p> <p>to the west/southwest or toward/under the CeramFab building from the major derailment/clean-up areas (see also Exhibit 151, Figures 1, 4-6):</p> <p><b>Figure 7-6: Arcadis Drawing of Derailment Area Groundwater Flow Direction to SW (see lower left) (Exhibit 55)</b></p> <p>Thus, released contaminants to the north and east would likely flow toward the Plaintiff's buildings.</p> |

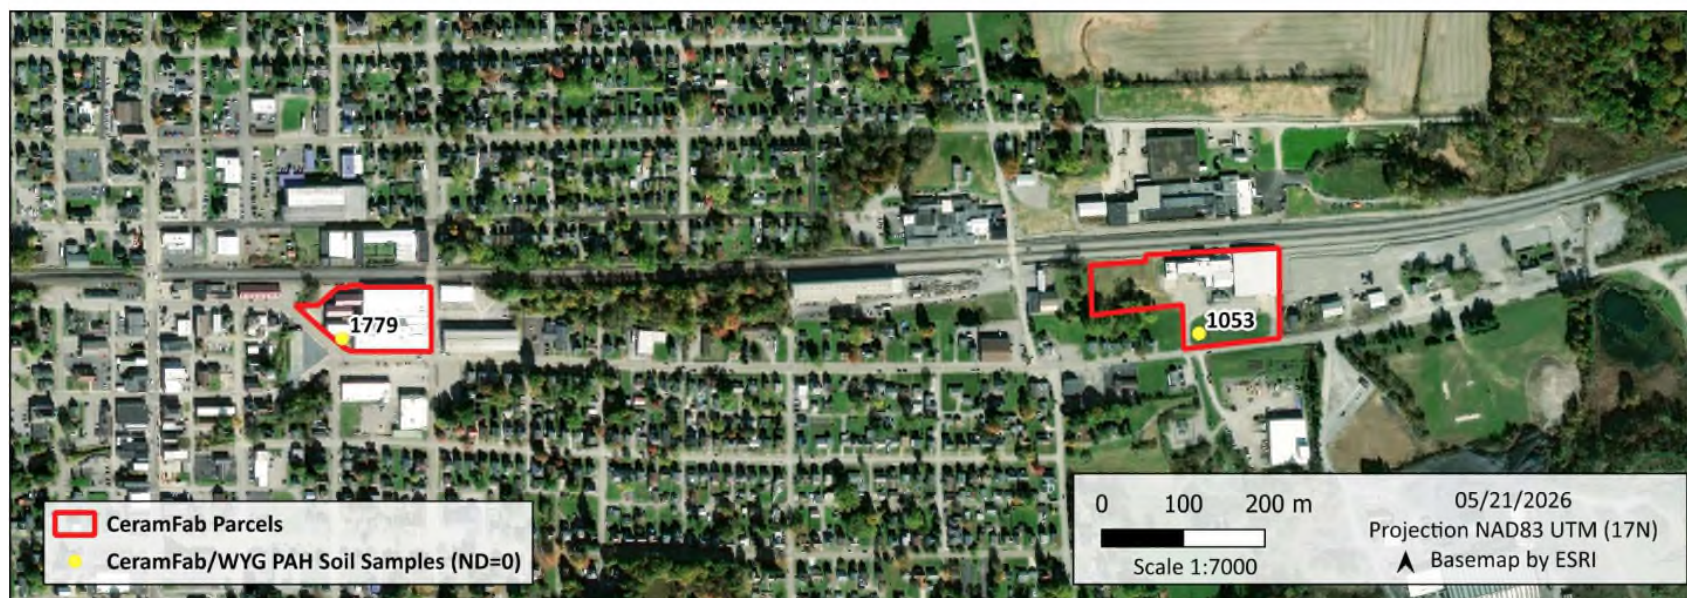
**Figure 3-1: Plot of Soil PAH BAP<sub>E</sub> Calculation Results for WYG and CeramFab Samples – Using 0% for DL Constituents– Note 50% Values Not Plotted as No DL's were Present**

These plots show elevated PAH and dioxin/furans remain in the Plaintiffs' soils even in 2026. When examined in conjunction with the other sampling results discussed earlier in this rebuttal and in the original report, it again demonstrates the failures in NS' sampling plans, its continued efforts to avoid determining the true impacts of its derailment related contaminate releases (by sampling air in 2026 – during a rain event, no less – instead of soil), the fallacy of its opinions that all contamination was remediated, and NS' opinions the reasonableness or repair/remediation opinions described in Plaintiffs' other expert reports are unwarranted or unsupported.

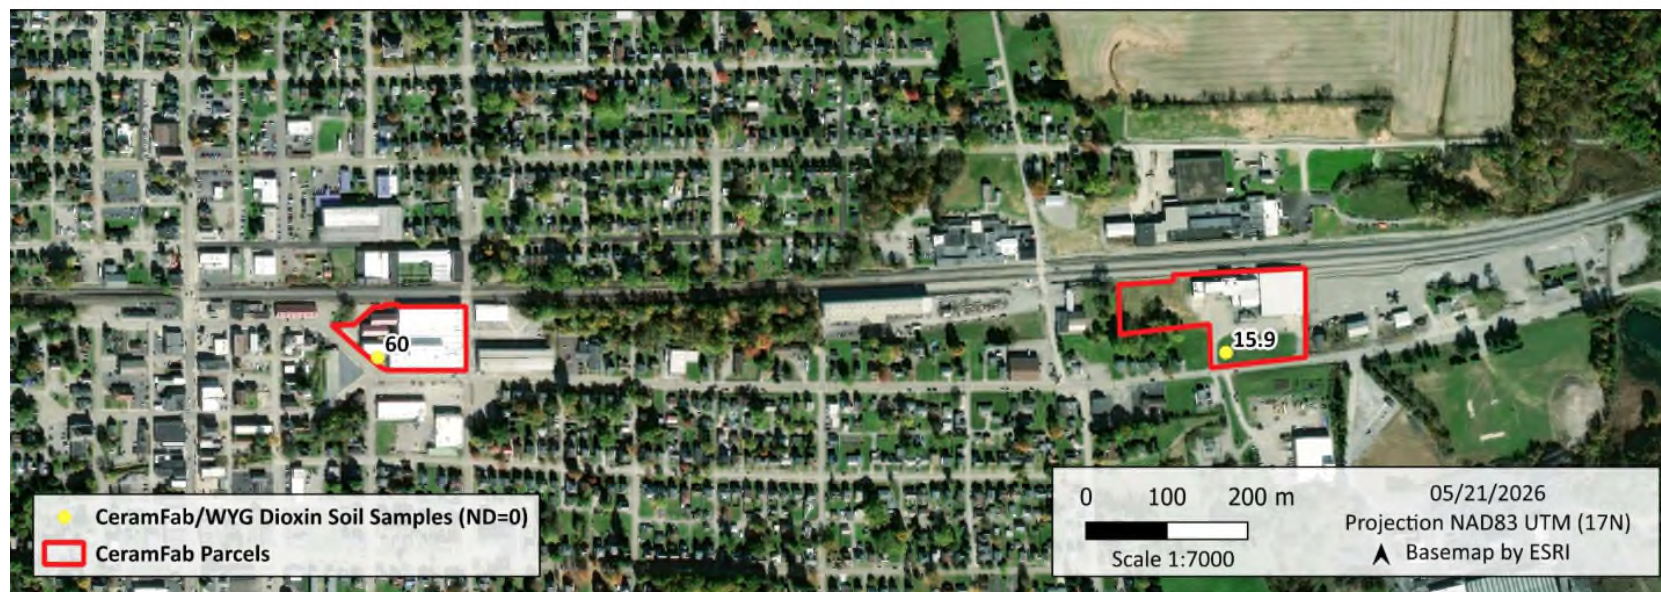
**Figure 3-2: Plot of Soil Dioxin/Furan TEQ Calculation Results for WYG and CeramFab Samples – Using 0% for DL Constituents – Note 50% Values Not Plotted as No DL's were Present**

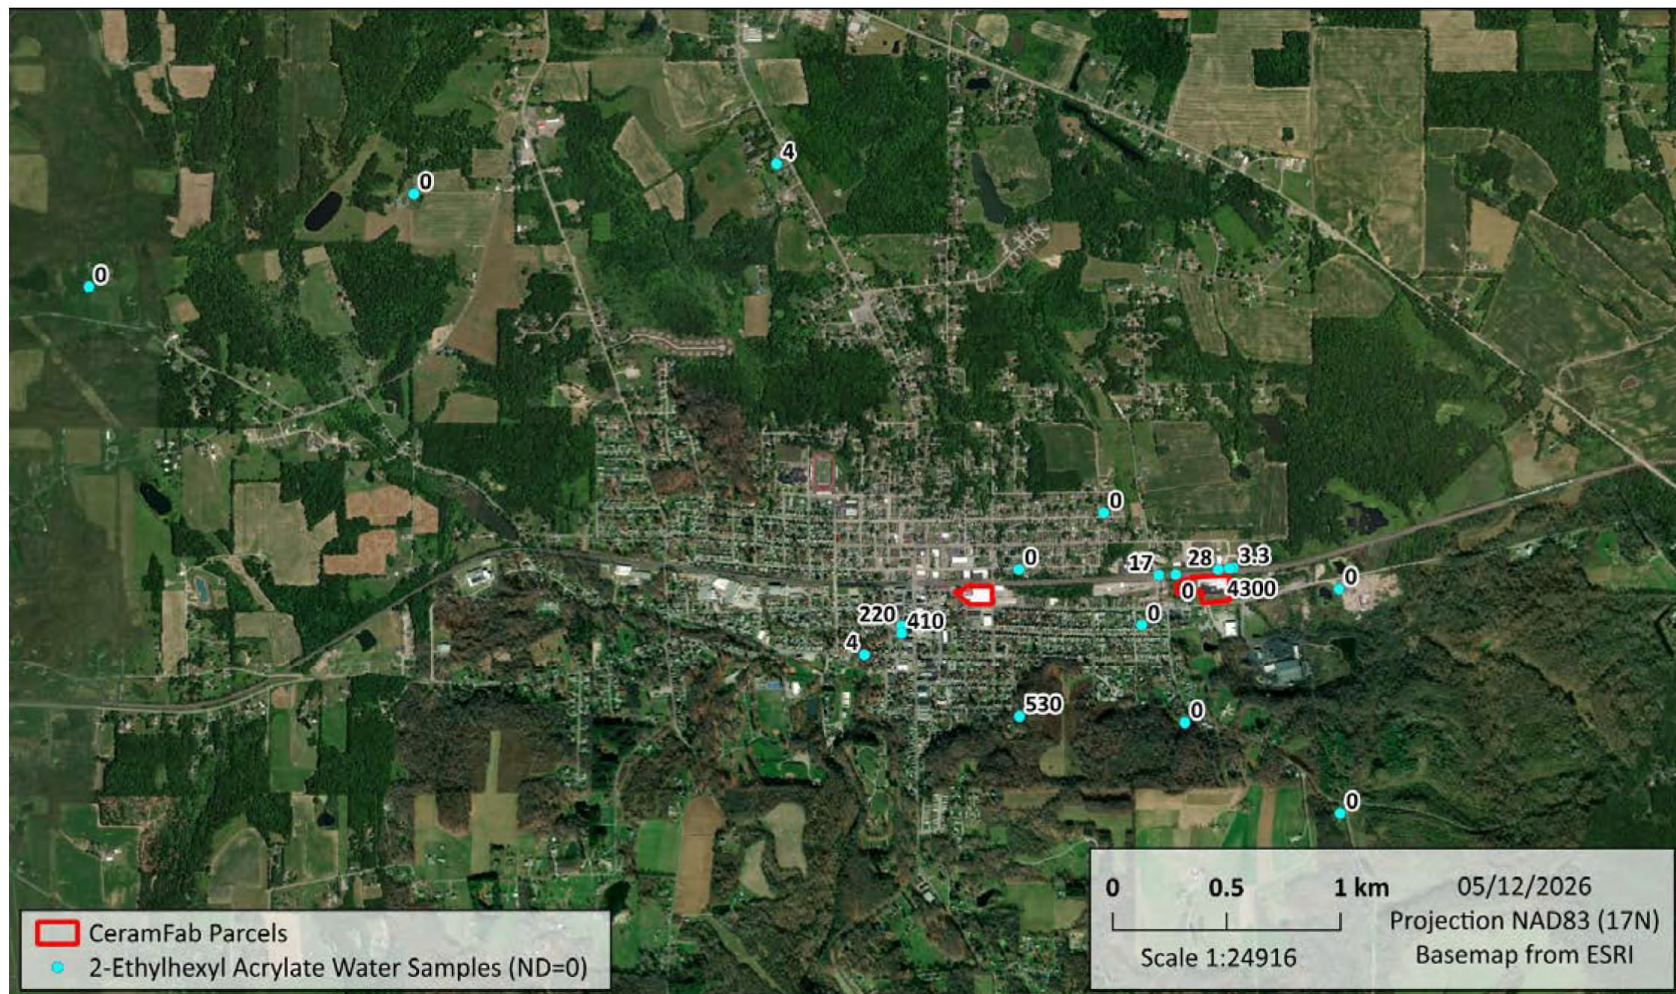
Figure 4-4: Plot of Water 2-Ethylhexyl Acrylate Sampling Results – Using 0 for DL Constituents

These plots show that known train car contents are basically found at higher levels at/near the derailment site and dilute, or are not present at all, farther away from this site. This supports the opinions offered here that the source of these contaminants is from the derailment and not from either unidentified background sources or other “empty chair” entities.

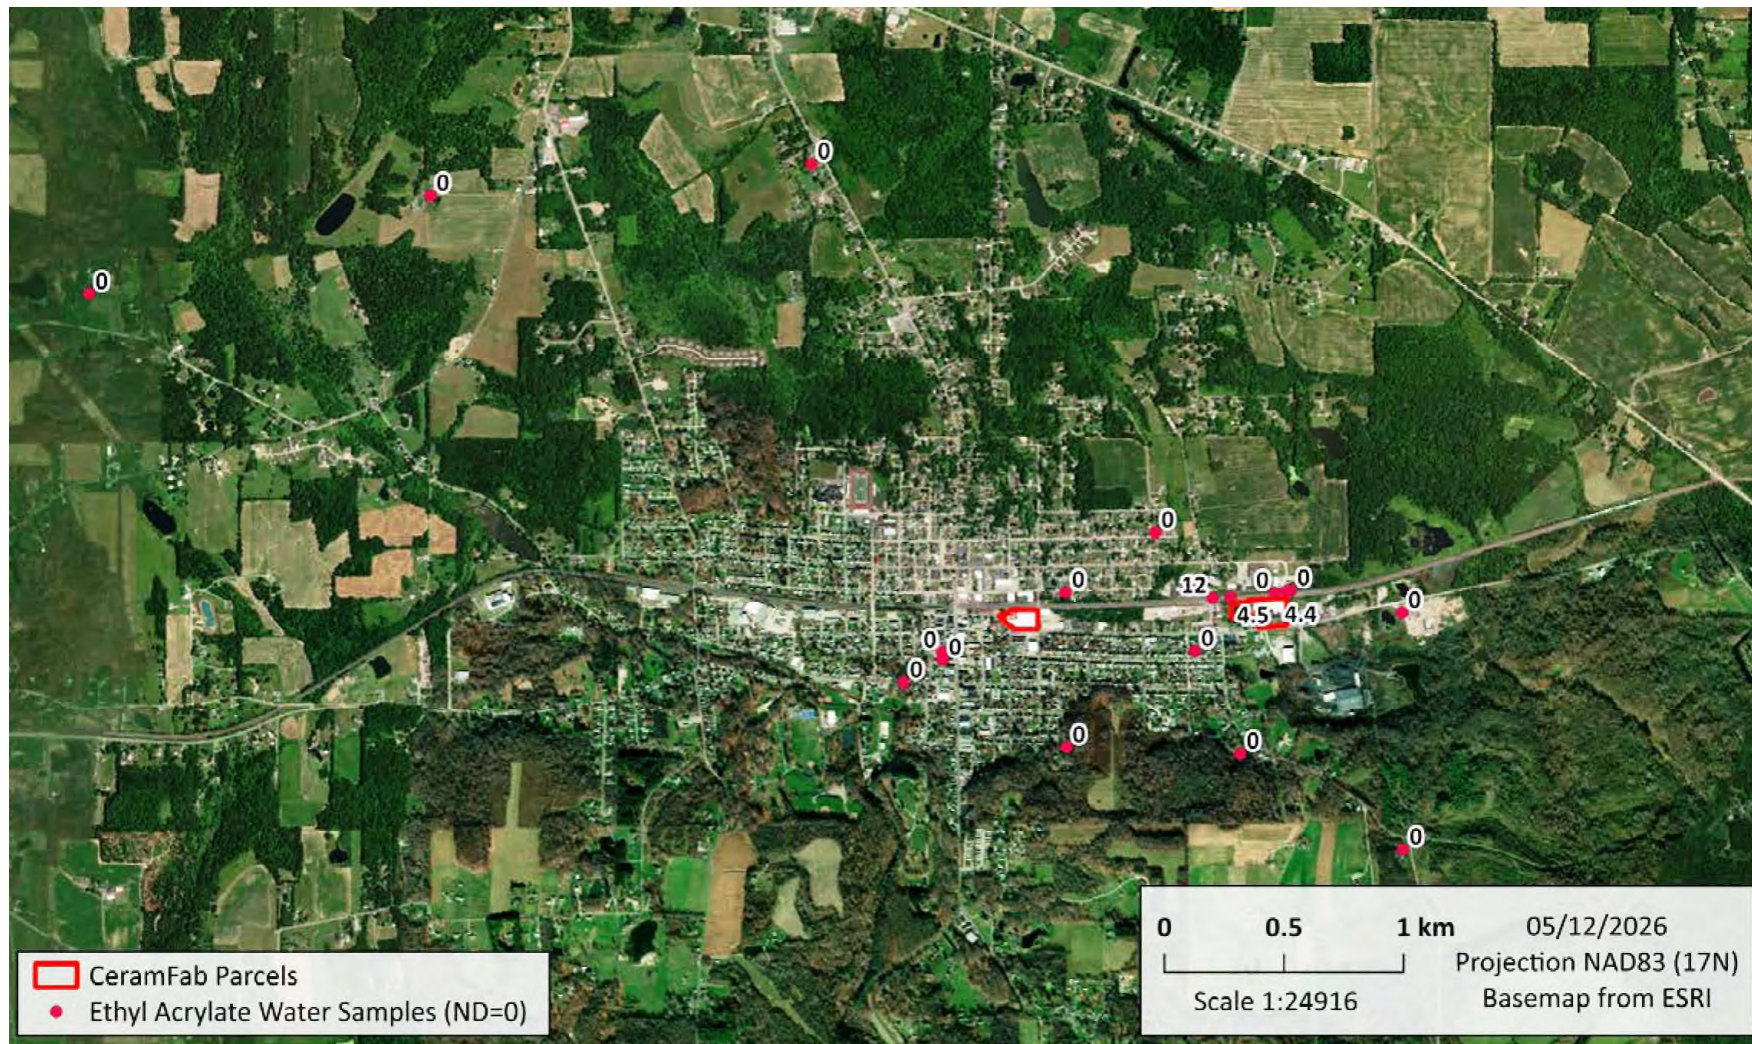
**Figure 4-5: Plot of Water Ethyl Acrylate Sampling Results – Using 0 for DL Constituents**

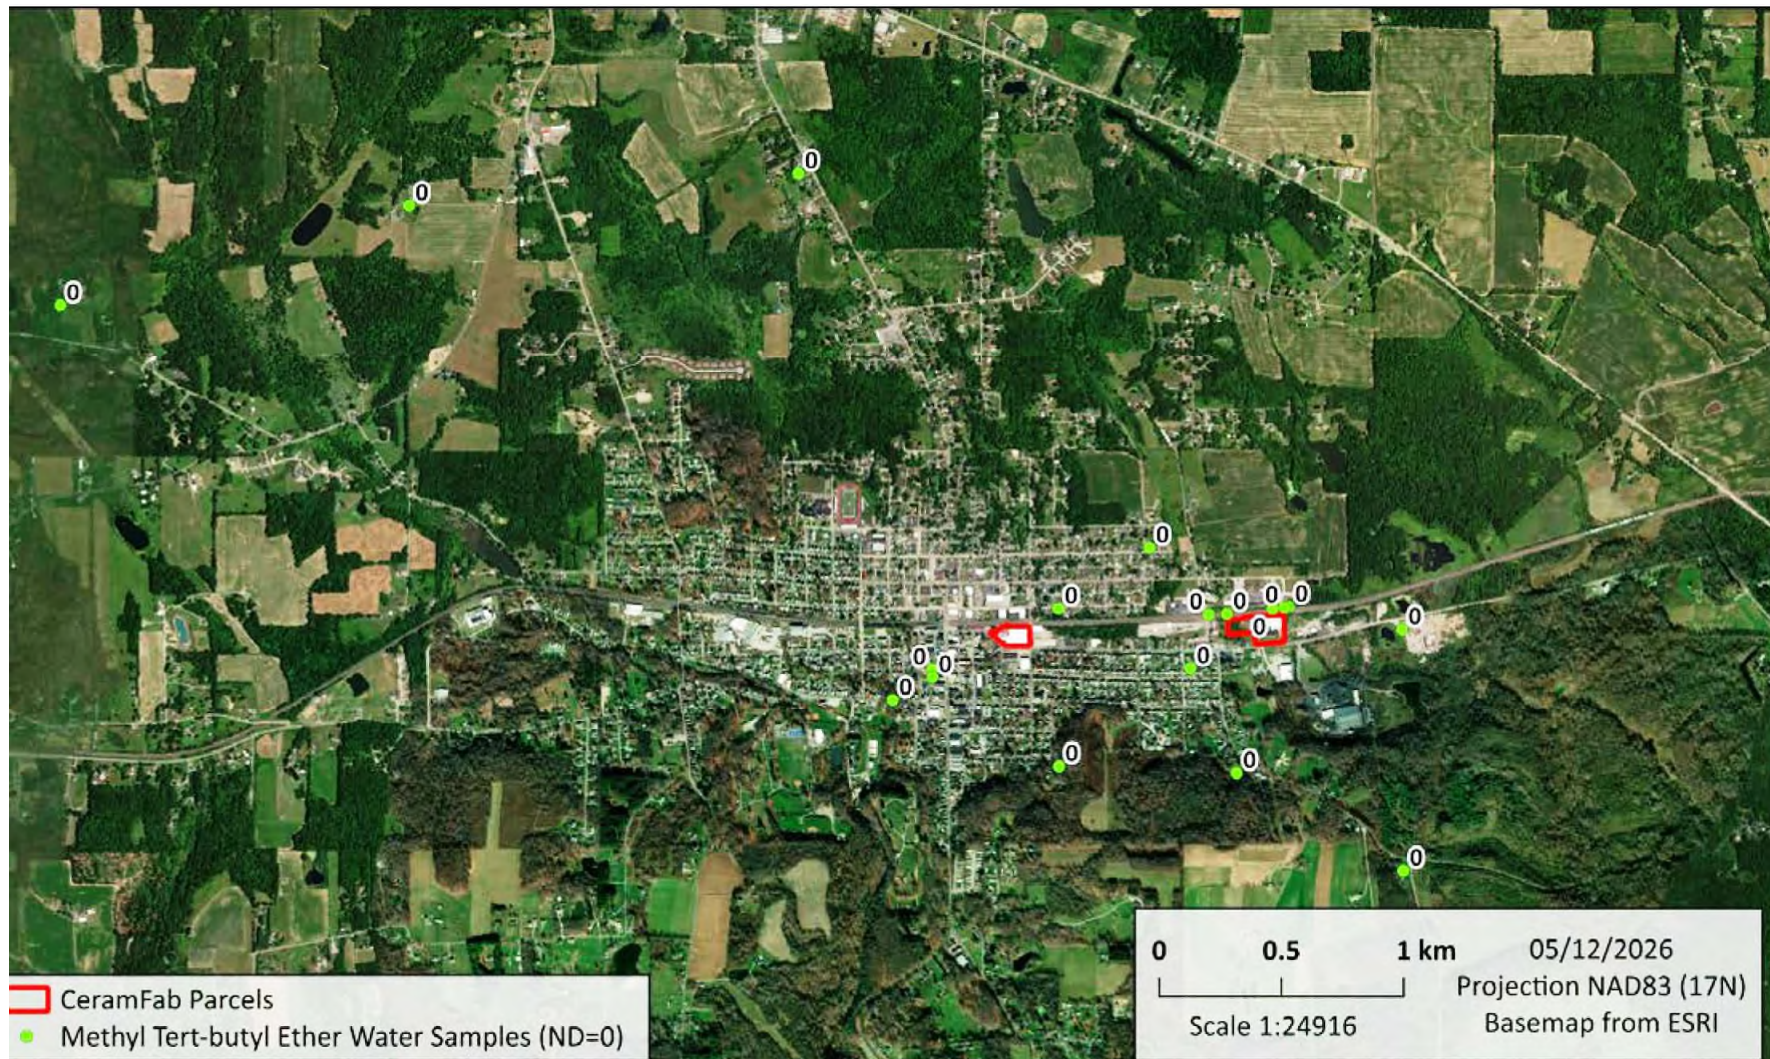
**Figure 5-2: Plot of Water MTBE Sampling Results – Using 0 for DL Constituents**

These MTBE plots, along with other information cited in my earlier expert report, or described elsewhere in this rebuttal, strongly suggest that it is more likely than not that the benzene found at the derailment site and on Plaintiffs' properties came from the derailed tank cars.

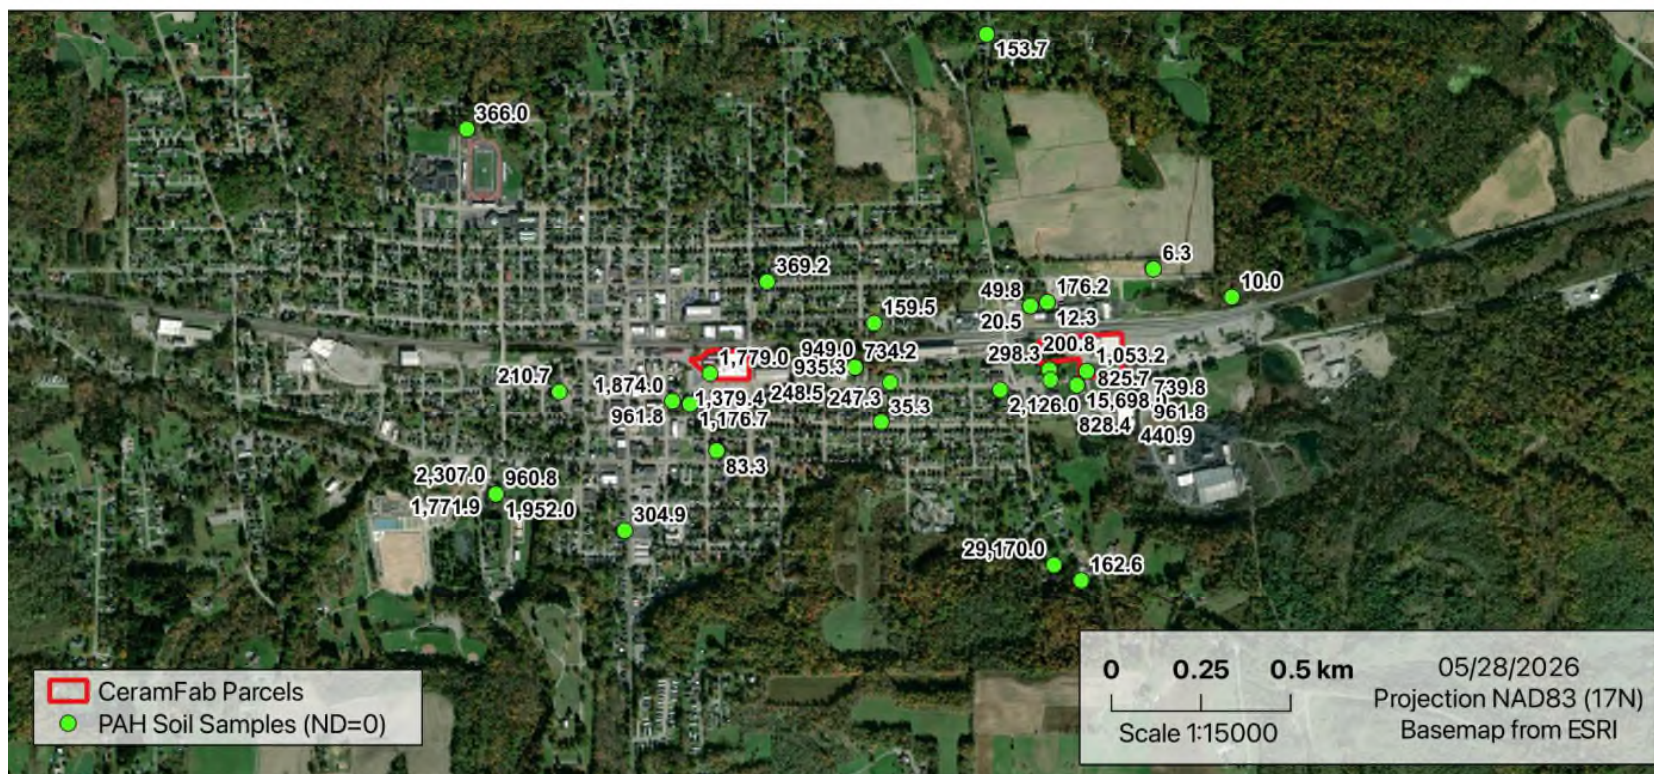
**Figure 6-2: Soil BaP<sub>E</sub> Calculation Results for Data Set #4 – Using 0 for DL Constituents – Closer**

Soil BaPE calculation results for Data Set #4 are shown plotted in Figures 6-1 through 6-4 and sediment calculation results for Data Set #4 are shown plotted in Figures 6-5 and 6-8 and further rebut NS' expert arguments that Plaintiffs' properties were/are not contaminated or that Plaintiffs' are not acting reasonably, as detailed in Plaintiffs' other expert reports:

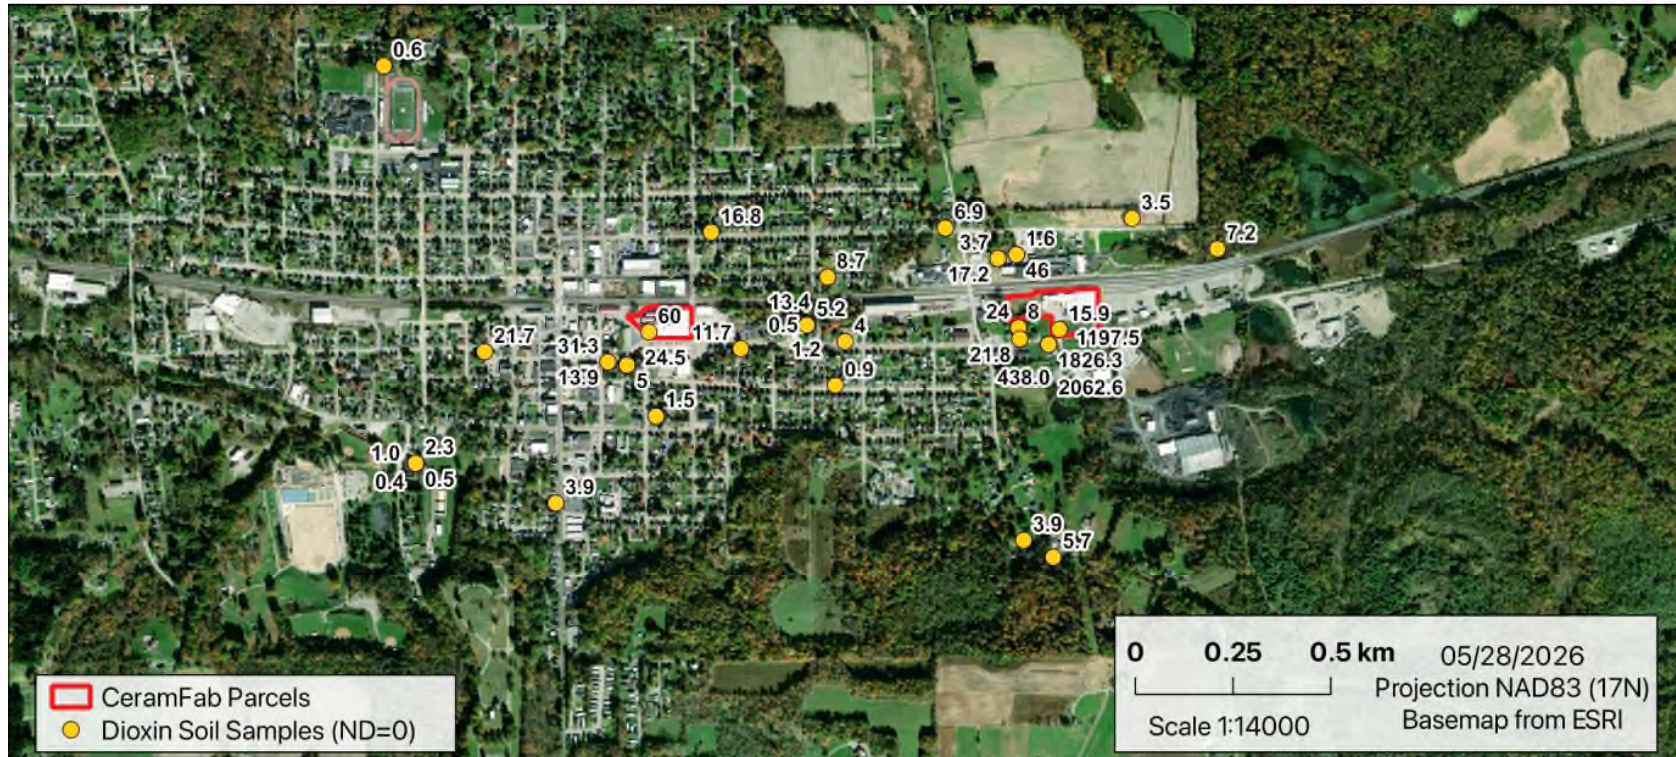
Figure 6-10: Soil TEQ Calculation Results for Data Set #4 – Using 0 for DL Constituents - Closer

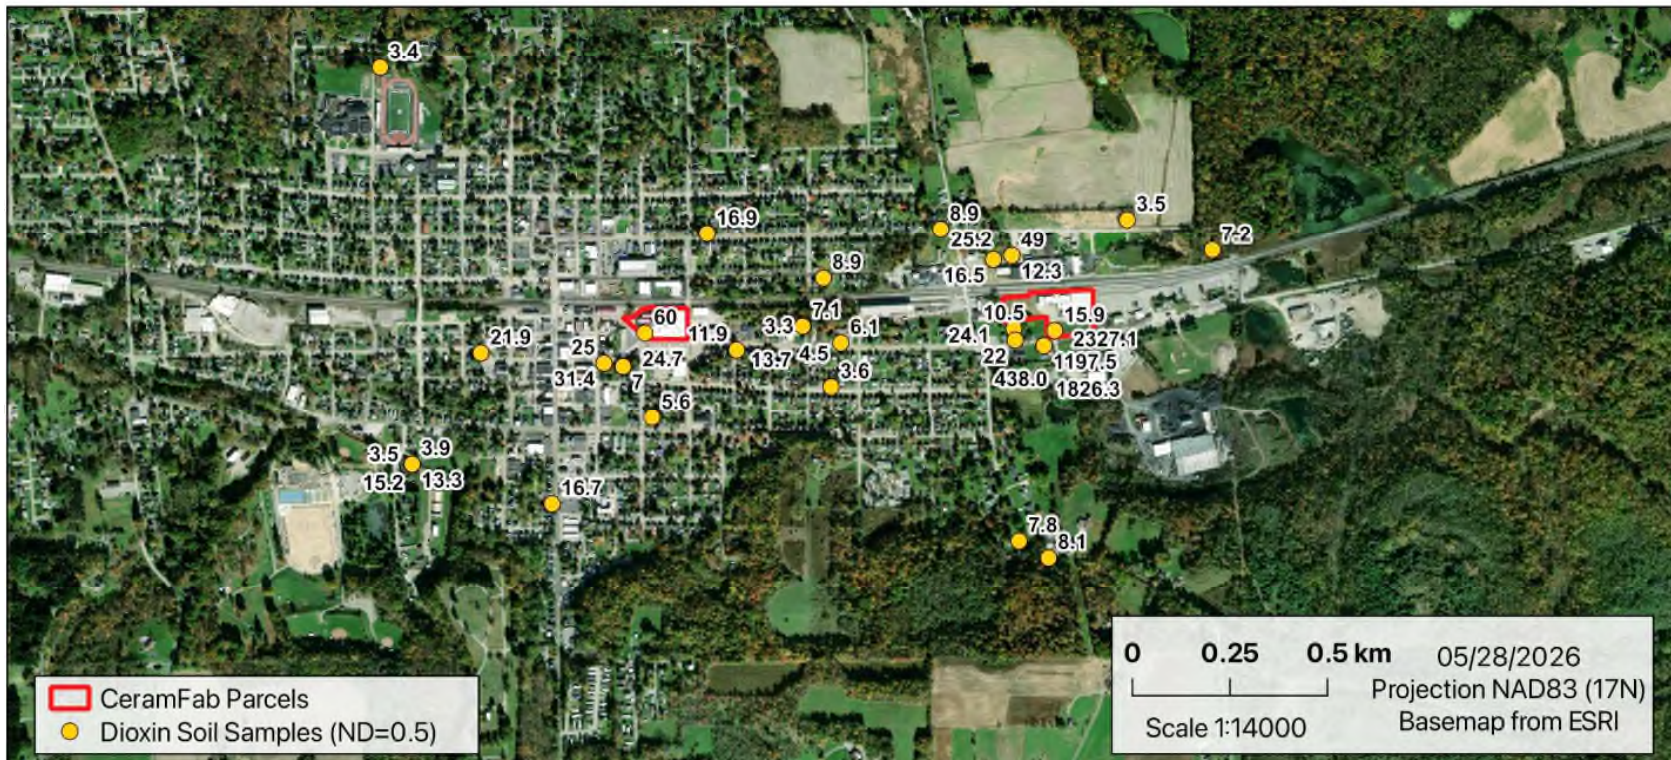
Figure 6-12: Soil TEQ Calculation Results for Data Set #4 – Using 50% of DLs for DL Constituents - Closer

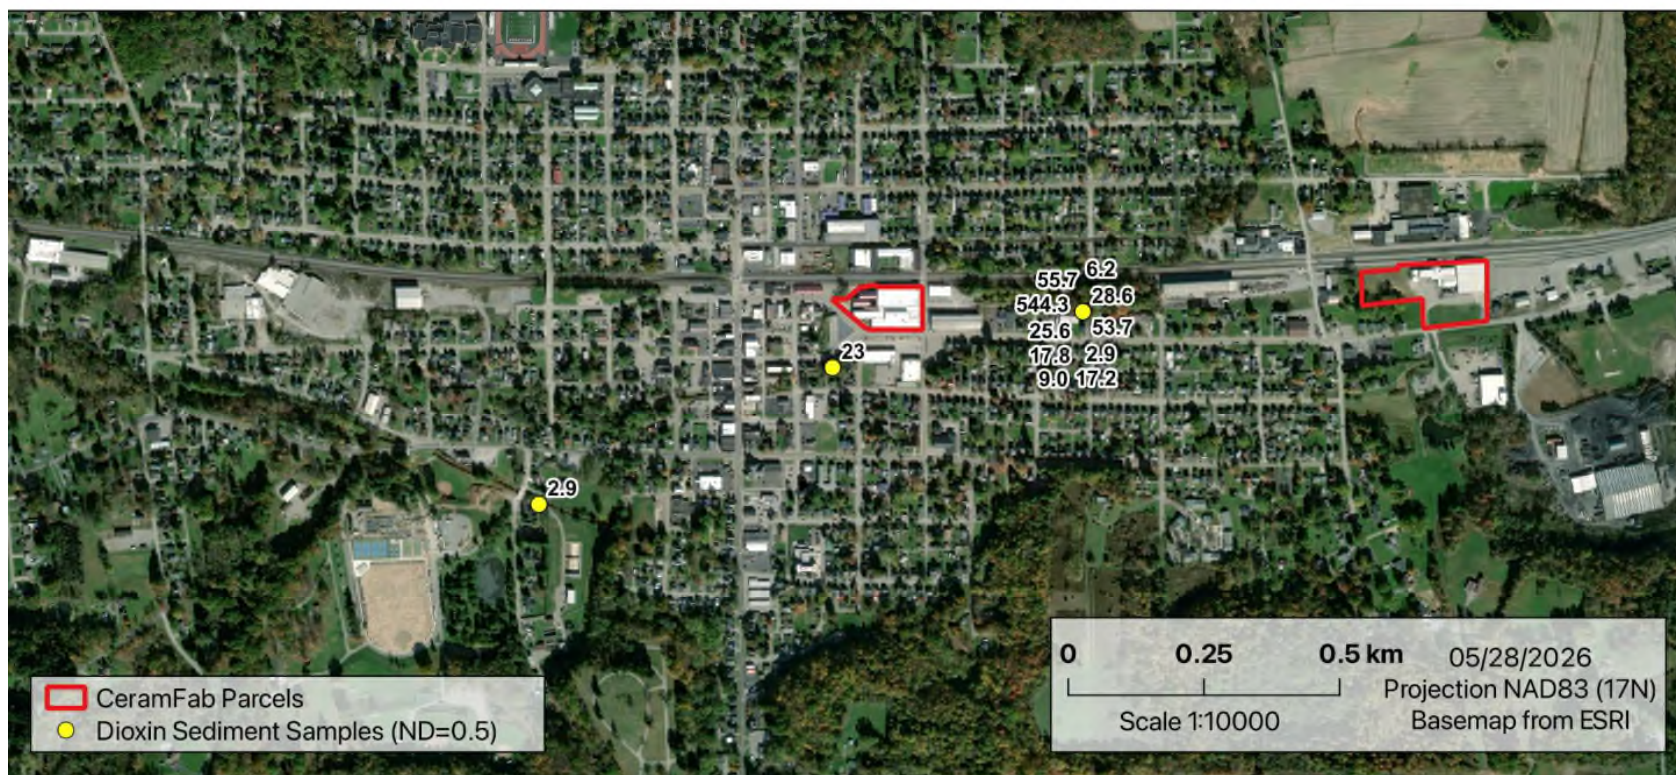
Figure 6-16: Sediment TEQ Calculation Results for Data Set #4 – Using 50% of DLs for DL Constituents - Closer

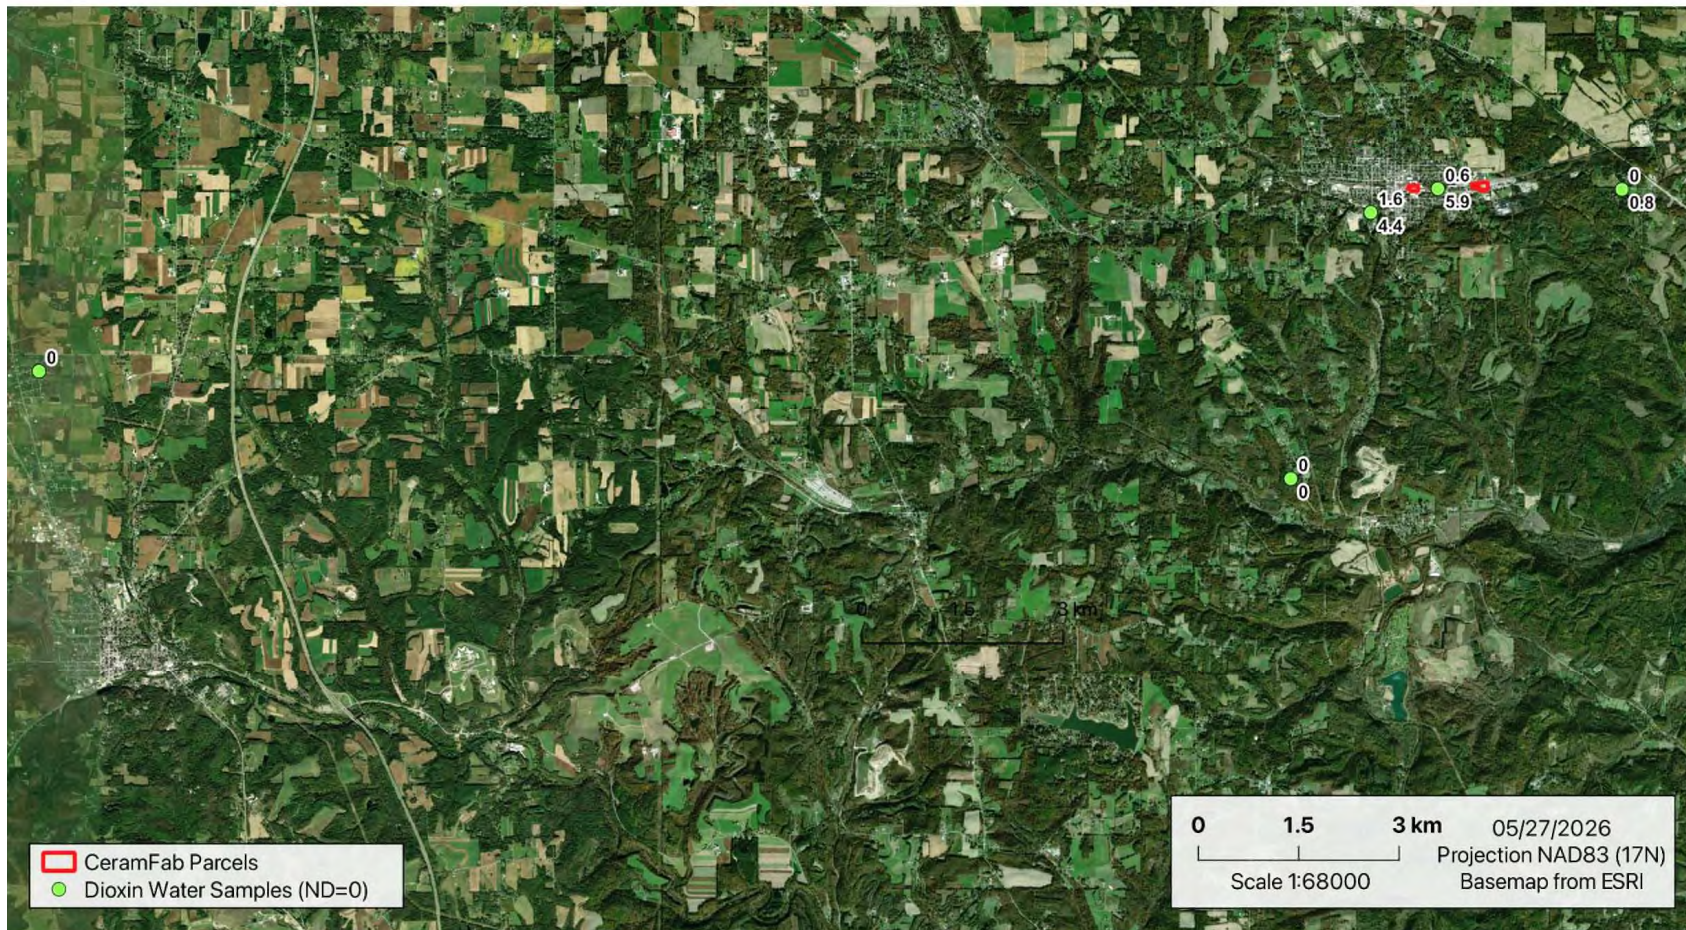
**Figure 6-17: Water TEQ Calculation Results for Data Set #4 – Using 0% of DLs for DL Constituents**
